HH-0849

# WRP Conveying Pebble Lime Pneumatically Ends Elbow Failure

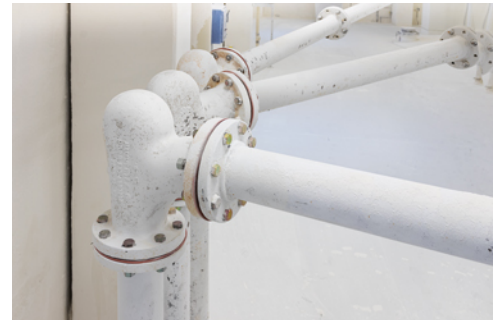
*The Upper Occoquan Water Reclamation plant has gone 16 years without an elbow failure after installing short radius Smart Elbow® deflection elbows.*

More than 16 years have elapsed since the installation of the deflection elbows at UOSA's facilities without a blowout. "With the Smart Elbow deflection elbow, we've eliminated the primary source of lime dust along with the hazardous conditions it creates," Forgione said. Maintenance and labor costs have been reduced, safety and air quality have been upgraded, and the buildings are visibly cleaner. He added, "The delivery was fast and our mechanics were able to install them quickly without complaints. If we ever get wear in an elbow anywhere in the plant, we'll replace it with one of these elbows."

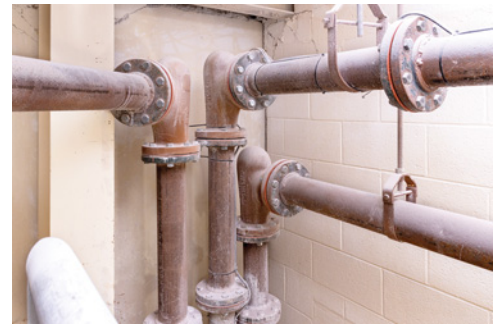
*Installing short-radius deflection elbows put an end to leaks, spills, replacements and associated costs encountered with other type elbows.*

45-degree, four-inch diameter elbows were installed where the trucks off-load their lime and twelve 90-degree, four-inch diameter elbows were installed at the tops of the silos. A custom alloy was specified based on characteristics of the pebble lime and the length and velocity of the pneumatic conveying system.
