TECHNICAL ARTICLE SERIES

HT-1009

Elbow Cuts Maintenance

HAMMERTEK CORPORATION

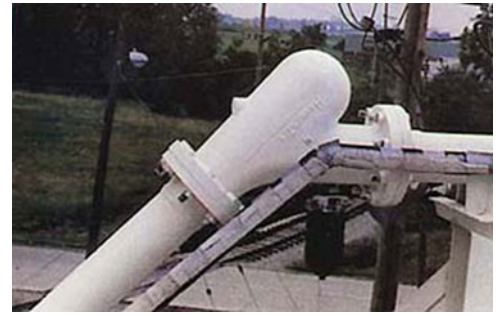
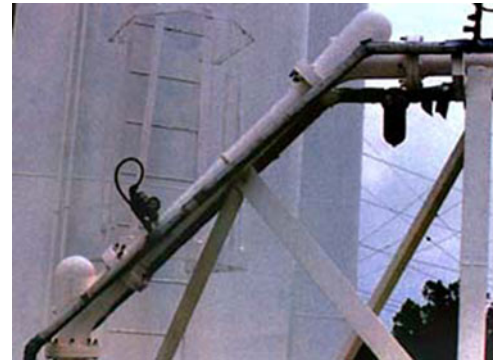
The elbow has a spherical chamber that works on an entirely different principle than most pneumatic elbows.

Some of the conveyed particles form a slowly rotating ball in the chamber. Other particles of the moving material are deflected by the material suspended in the air and given off by this soft, rotating ball. Instead of worn walls, the moving material and the air take all the abuse.

The material in the chamber is undamaged. This spherical mass of material is slightly off-center, so that the soft ball rotates-absorbing new material at the top and losing material at the bottom. The ball is self-renewing and the gentle deflection of the conveyed material is constant.

With the ceramic elbows, the silica aggregate was deflected by the outer wall and the abrasive action destroyed the elbow.

With the spherical chamber elbow, the soft rotating ball deflects the silica aggregate and eliminates the abrasive action.
