HT-1022

Wastewater Treatment Plant Eliminates Pipe Failures from Pneumatic Conveying Line

The Smart Elbow® Deflection Elbow Stops Lime Spills and Prevents Dust Cloud Exposure

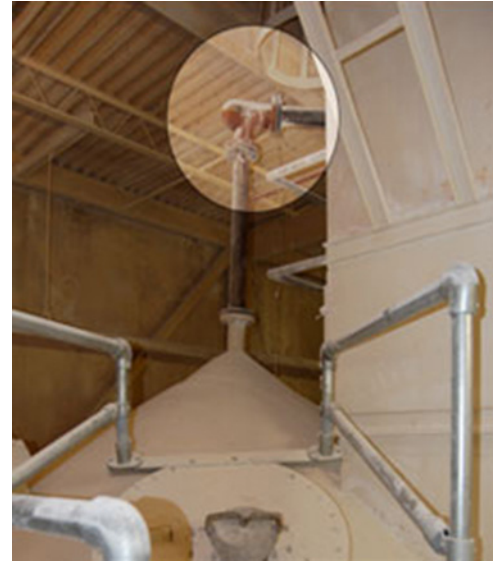
This 90-degree Smart Elbow deflection elbow from HammerTek, Bethlehem, Pa., diverts the pebble lime in the pneumatic conveying line into a silo for storage. The sharp turn that had tormented many different types of elbows has not been a concern for the Smart Elbow deflection elbow, nor for facility management.

The Smart Elbow design is based on the natural flow patterns of fluids. It combines a rounded chamber on a tight radius elbow in a single, rugged unit. The conveyed particles gather and swirl inside the chamber in a slowly-rotating, self-renewing ball, absorbing new material while gradually releasing it in a first-in, first-out progression. Incoming particles deflect off of this rotating ball of air and material and continue to the silo. Rather than inviting the material to collide with the elbow wall, this elbow virtually eliminates such wearing impact, instead causing gentle deflections that promote directional change without affecting system pressure.

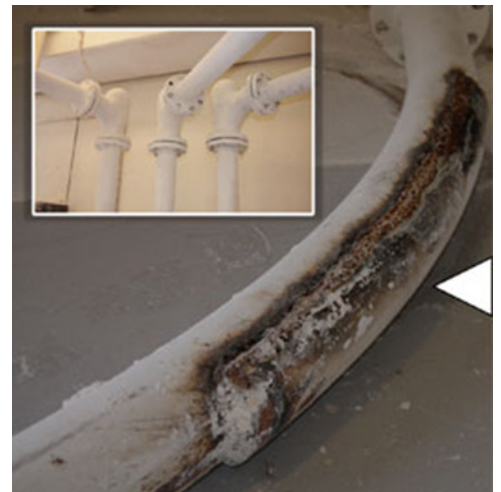
This sweep elbow is one of many that failed to handle the abrasive pebble lime used in the treatment process at the upper Occoquan Water Reclamation plant in Centreville, VA. Such elbow failures, which caked the facility with lime dust as shown on the floor, were plaguing the facility.

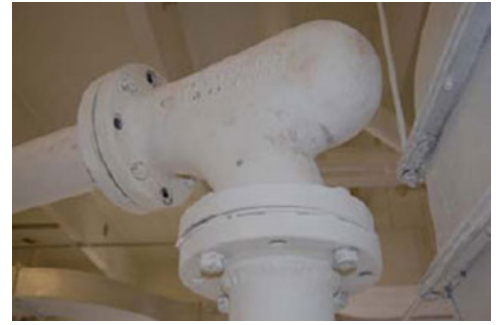
This HammerLoy™ Series Smart Elbow deflection elbow from HammerTek, Bethlehem, PA, is one of 14 such elbows installed at the upper Occoquan Water Reclamation Plant in Centreville, Va. To eliminate pipe failures in the conveying line. After more than four years in operation, all of the Smart Elbow deflection elbows continue to perform as specified without a single pipe failure.

This HammerLoy™ Series Smart Elbow model from HammerTek, Bethlehem, PA., is one of 14 such elbows installed at the Upper Occoquan Water Reclamation Plant in Centreville, Va. to eliminate pipe failures in the conveying line. After more than four years in operation, all of the Smart Elbow units continue to perform as specified without a single pipe failure.
