TECHNICAL ARTICLE SERIES

II-0391

Deflection Elbows End Blowouts in Conveying Sand to Silo

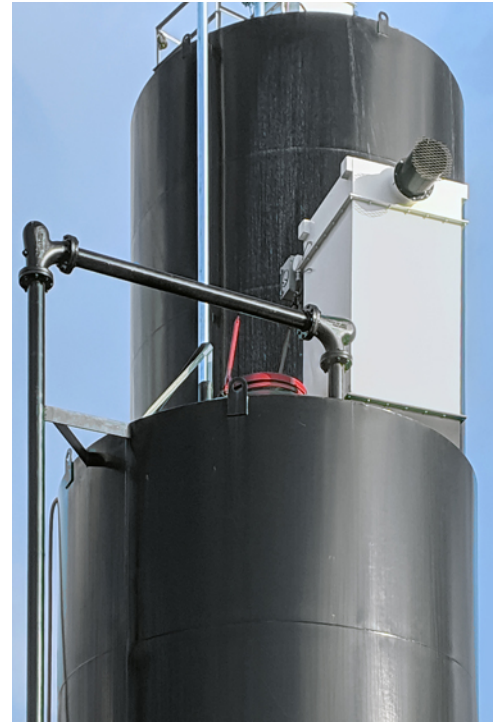
Deflection elbows eliminated abrasive elbow wear, blowouts, labor and downtime related to these two 90° bends.

The deflection elbows prevent sand from impacting the elbow wall, which has eliminated elbow failure. Blow-outs, which previously shut the conveying system down every few months, have not occurred in years.

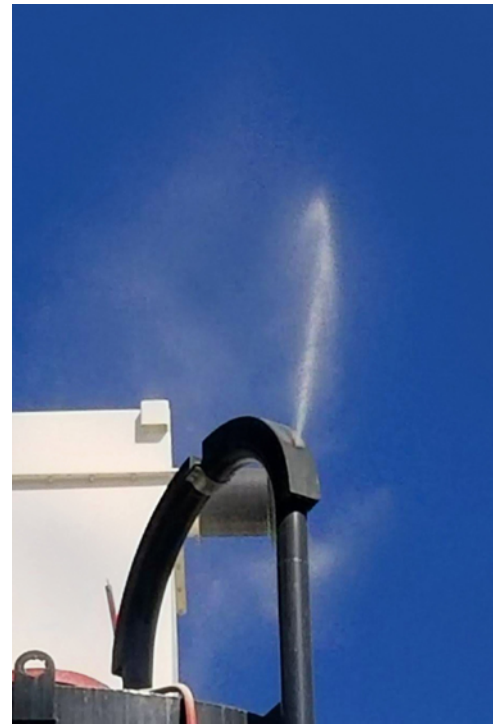
Abrasive silica sand for pavement products conveyed at 1000 cfm (0.47 cu m/sec) through steel pipes was blowing out long sweep elbows and reinforced elbows at Sealmaster, Allentown, PA.

The company has been offloading sand at this location for about six years, but according to plant manager, Curt Stein, "We had problems since day one. As soon as it began to turn, the sand would erode or eat through the sweep elbow and eventually just shoot out the side.

"We went to a heavier elbow, but that didn't work. The sand just ate through it within weeks.

"Then we went to a concrete-reinforced elbow. Within a couple of months, it ate right through the inner steel lining, through the concrete, through the outer steel lining and shot out again."

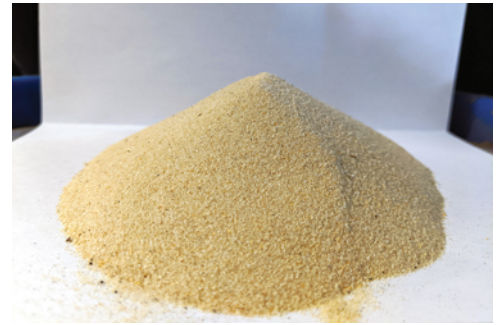
Silica sand, at 60 mesh (250 micron) is pneumatically conveyed from trucks 20 ft (6 m) up into the silo.

The company's Allentown, PA plant uses silica sand as a filler to improve durability and add skid resistance to its line of pavement sealers. The 60 mesh (250 micron) sand arrives by truck with a pneumatic trailer equipped with a 1000 cfm (0.47 cu m/sec) blower. A length of 4-inch (10 cm) flexible hose connects the trailer to the 4-inch (10 cm) schedule 40 pipe of the silo, which is routed 20 feet (6 m) vertically, 7 ft (2 m) horizontally and then downward to feed the silo, requiring two elbows.

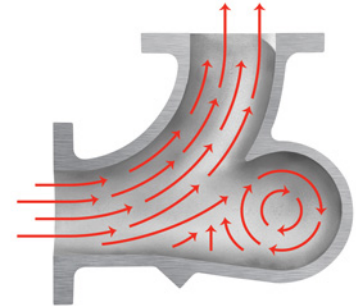
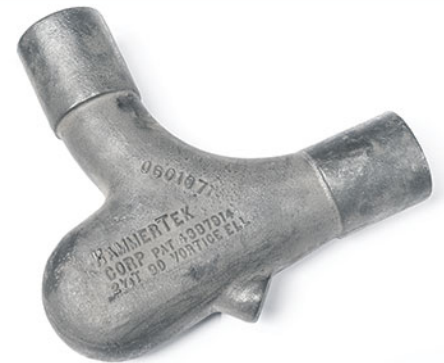
The deflection elbow's short radius, vortex design features a protruding spherical chamber that causes a ball of material suspended in air to rotate, gently deflecting incoming material around the bend without impacting the elbow wall or generating heat.

Unlike conventional elbows that rely on material impact to change direction, the company's Smart Elbow® design employs a spherical chamber that protrudes partially beyond the desired 90° or 45° pathway, causing a ball of material suspended in air to rotate. Since the ball of material rotates in the same direction as the airstream that powers it, incoming material is cushioned by the ball's rotation, and is gently deflected around the bend.
